Limited Visual Dam Safety Inspection Summary Report

MA-055

Wahikuli Reservoir

May 2006

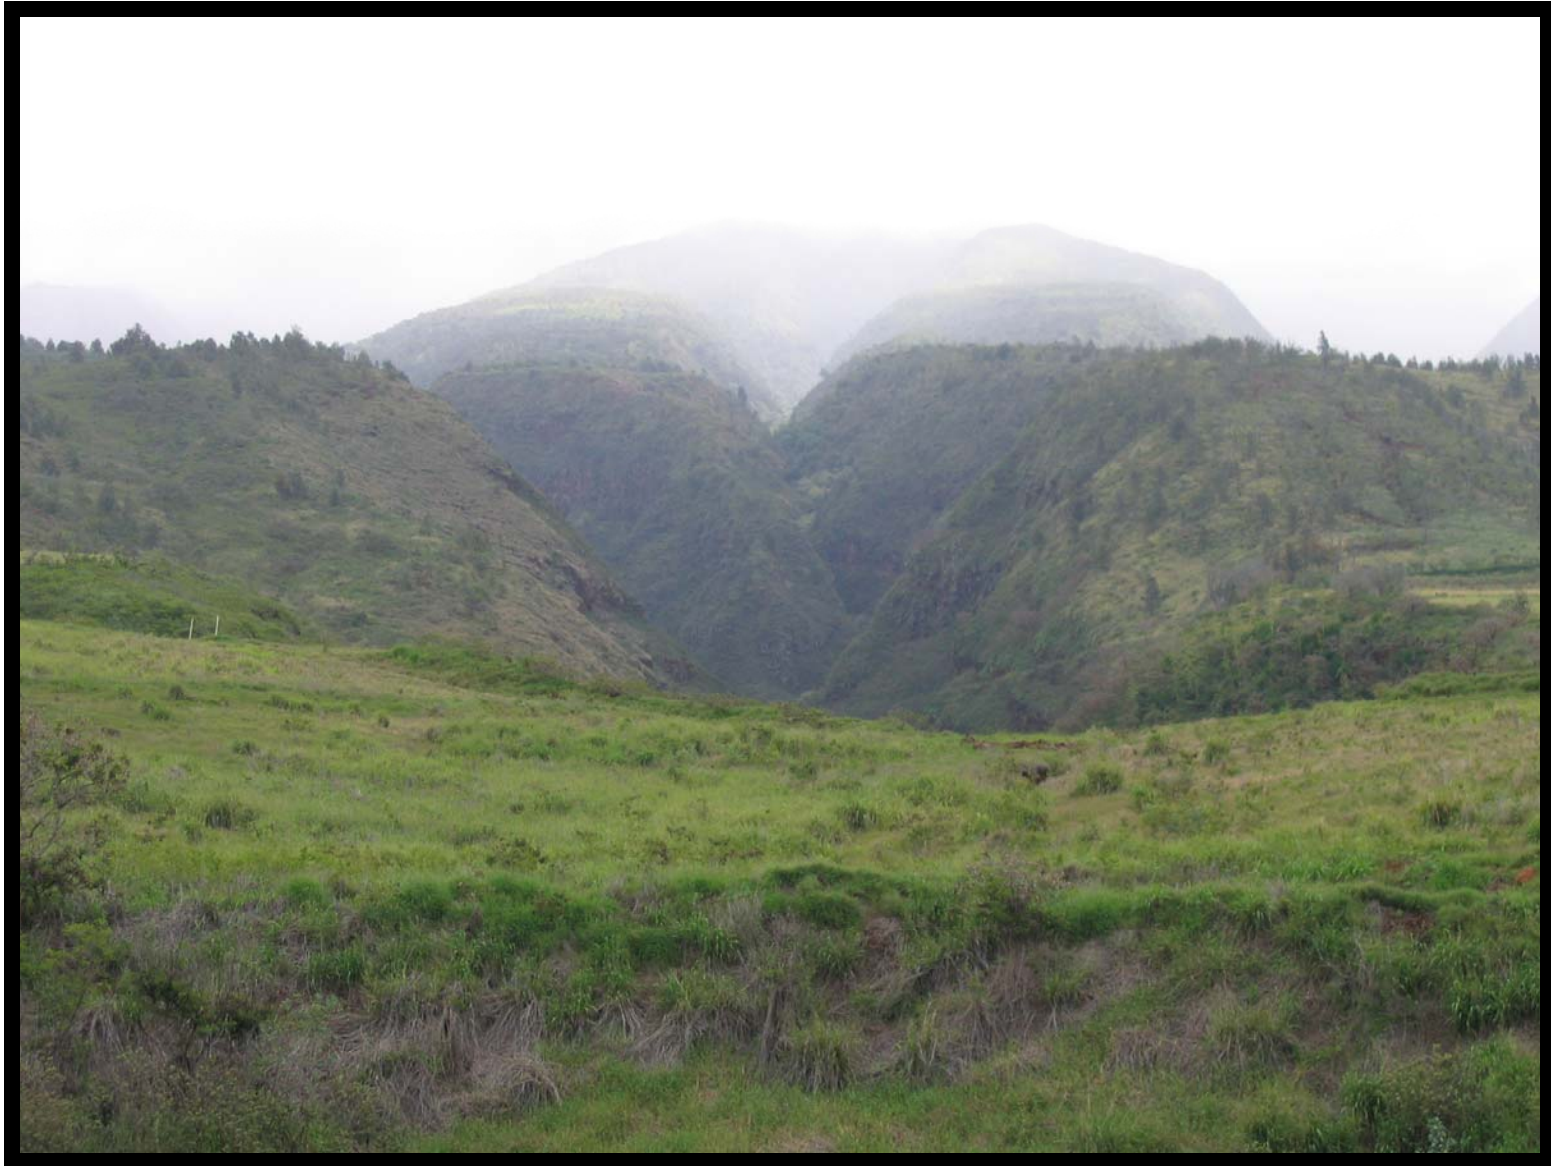
055 Upstream and adjacent drainage gouge

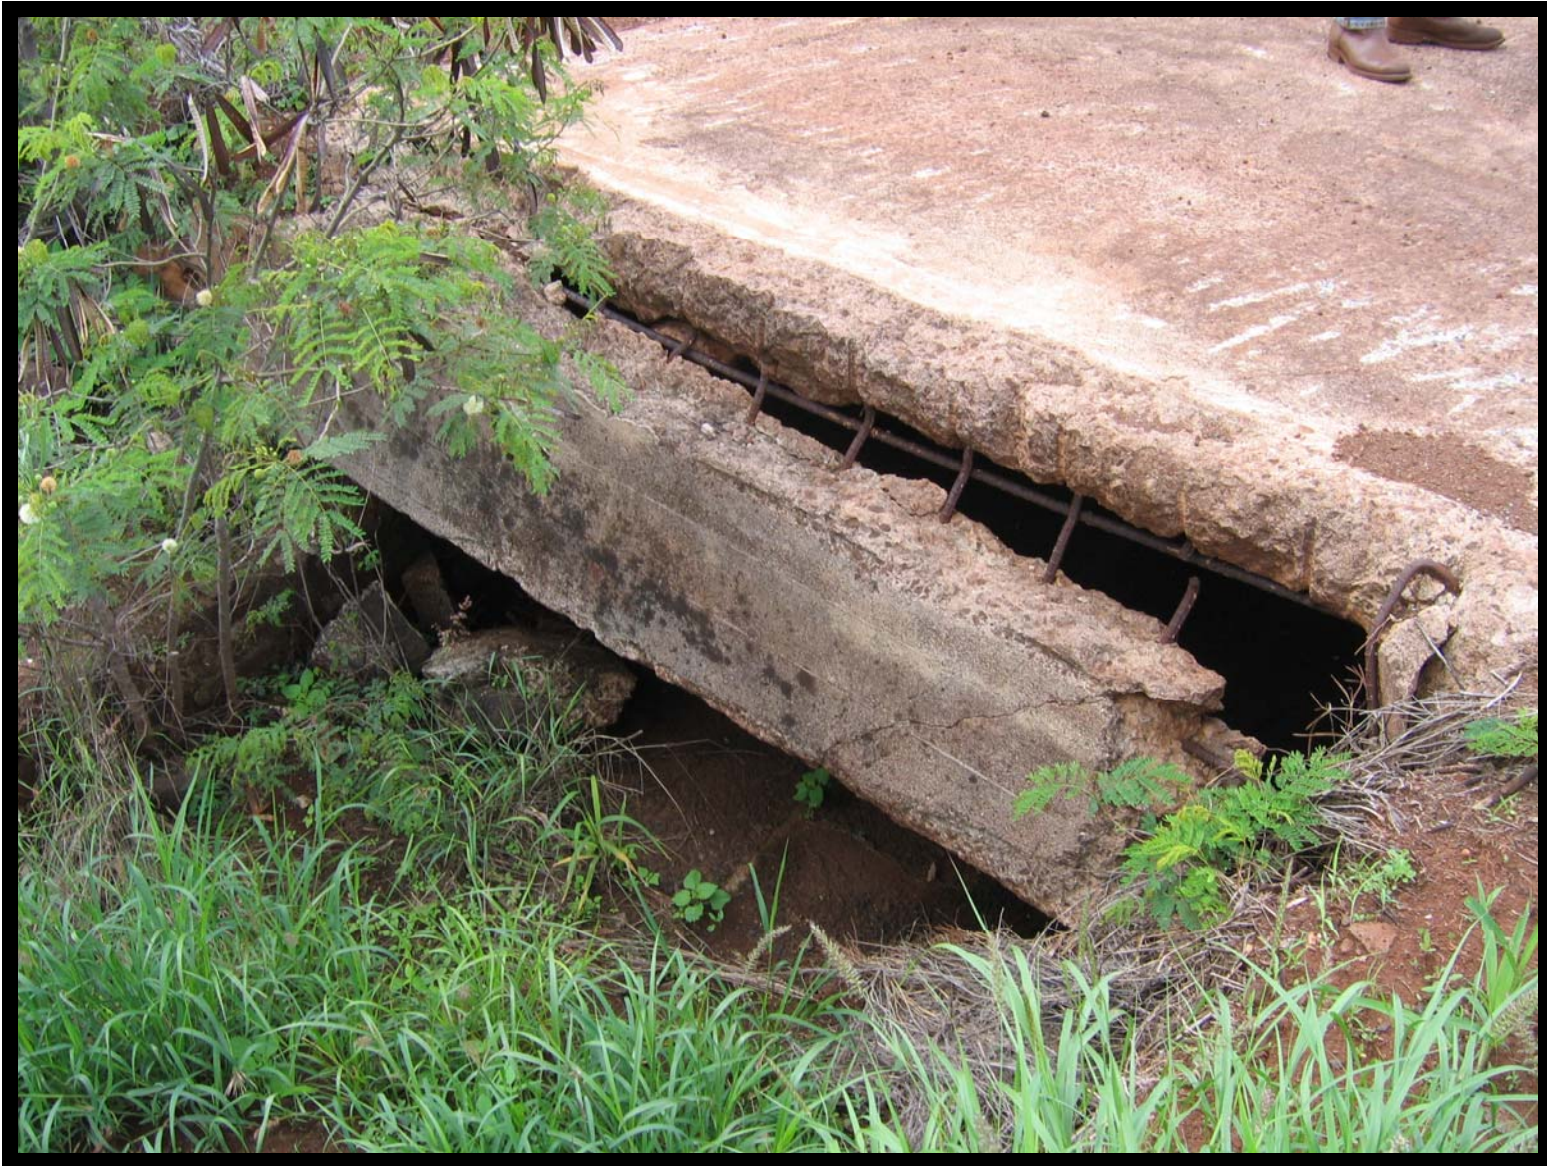
055 View of concrete access bridge over upper reservoir spillway.

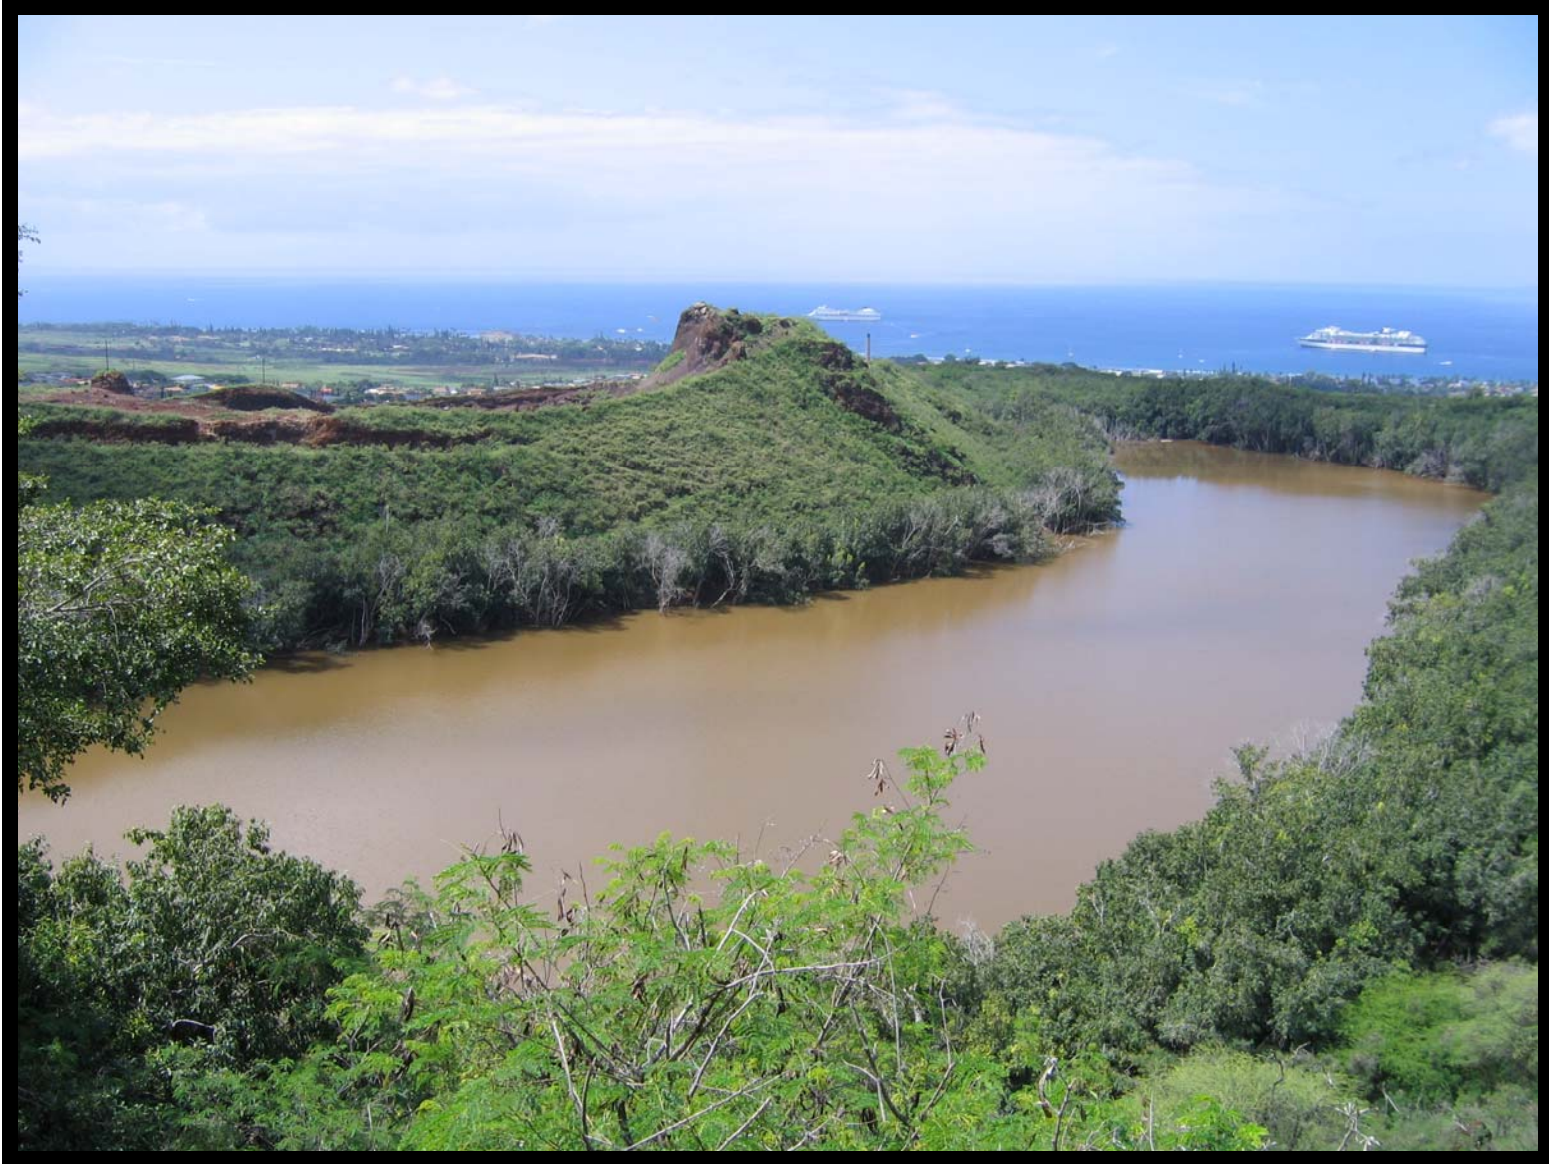
055 View of Crater Lake looking downstream that reservoir empties into

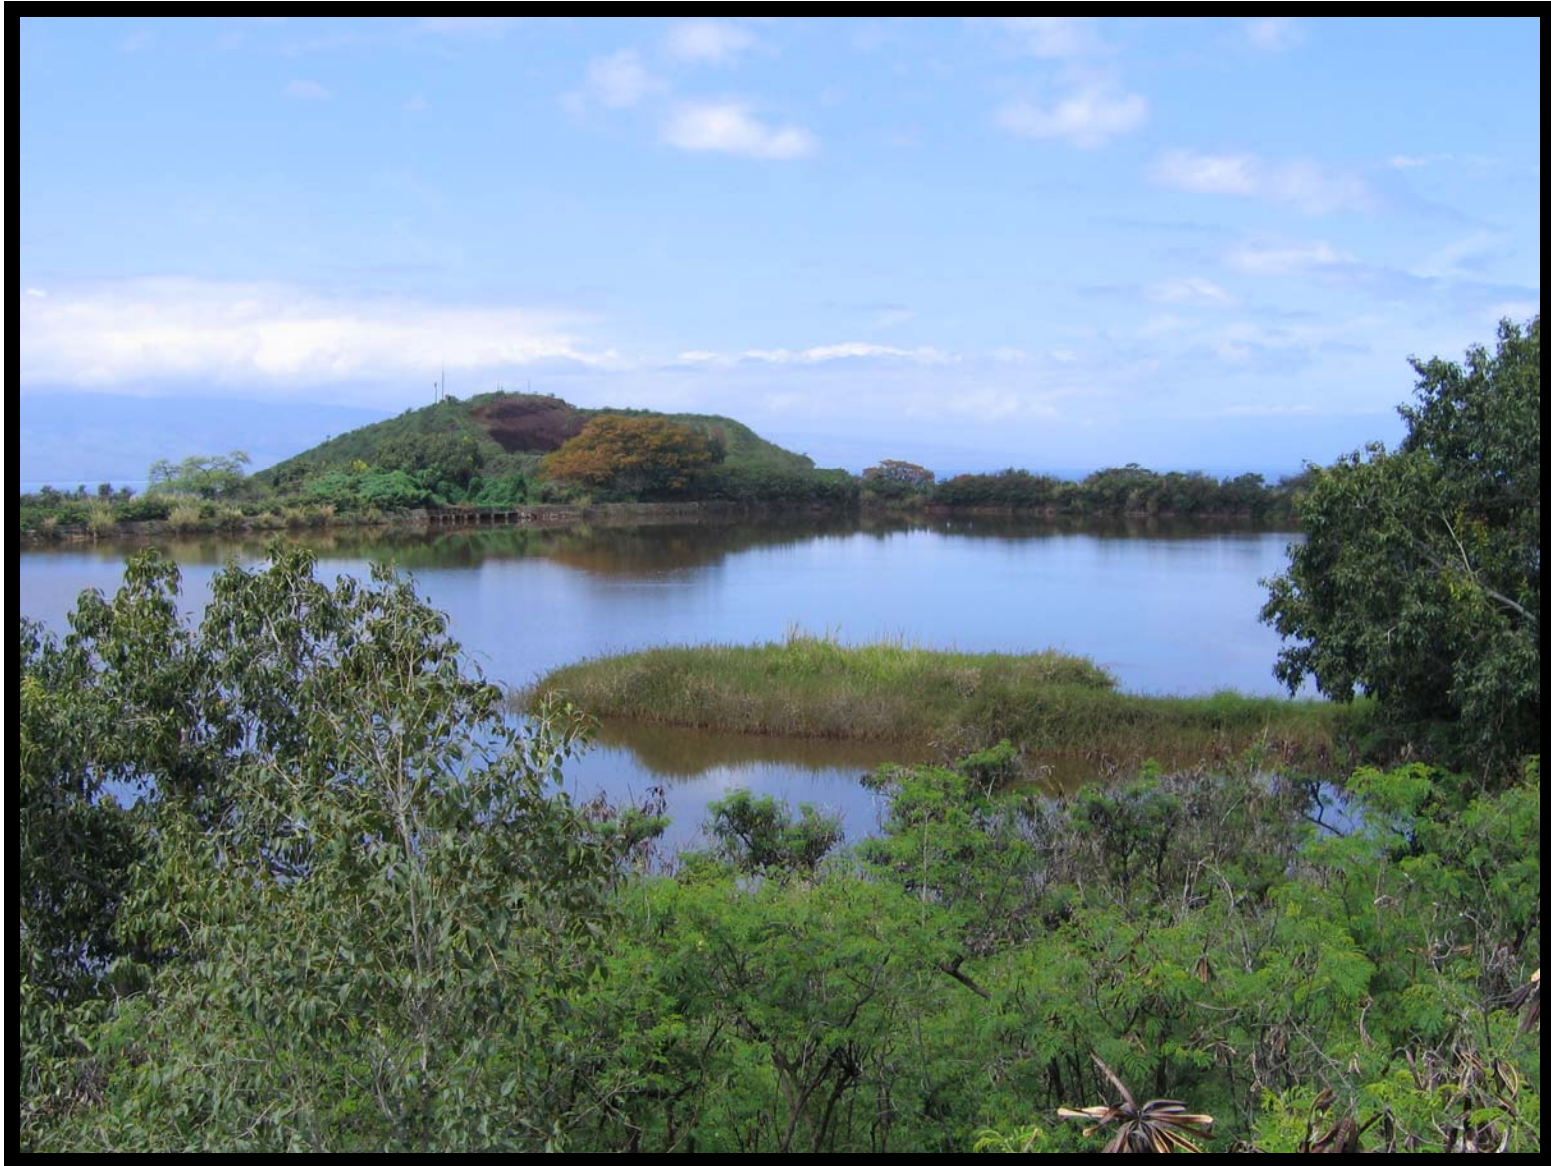
- c. Tree(s) were observed on the downstream slope. Trees have been identified as the probable cause of piping failures, and can possibly cause severe damage to the embankment if they are uprooted during high winds. Corrective action is required to remove the tree hazards from the dam. Acceptable remedies include removal of the tree and its root structure down to a 2" diameter and reconstruction the damaged embankment section. All repair work shall be accomplished as per the requirements of licensed geotechnical or structural engineer. Routinely monitor the damaged area for signs of settlement and seepage.

055 Downstream view of reservoir showing massive tree growth.

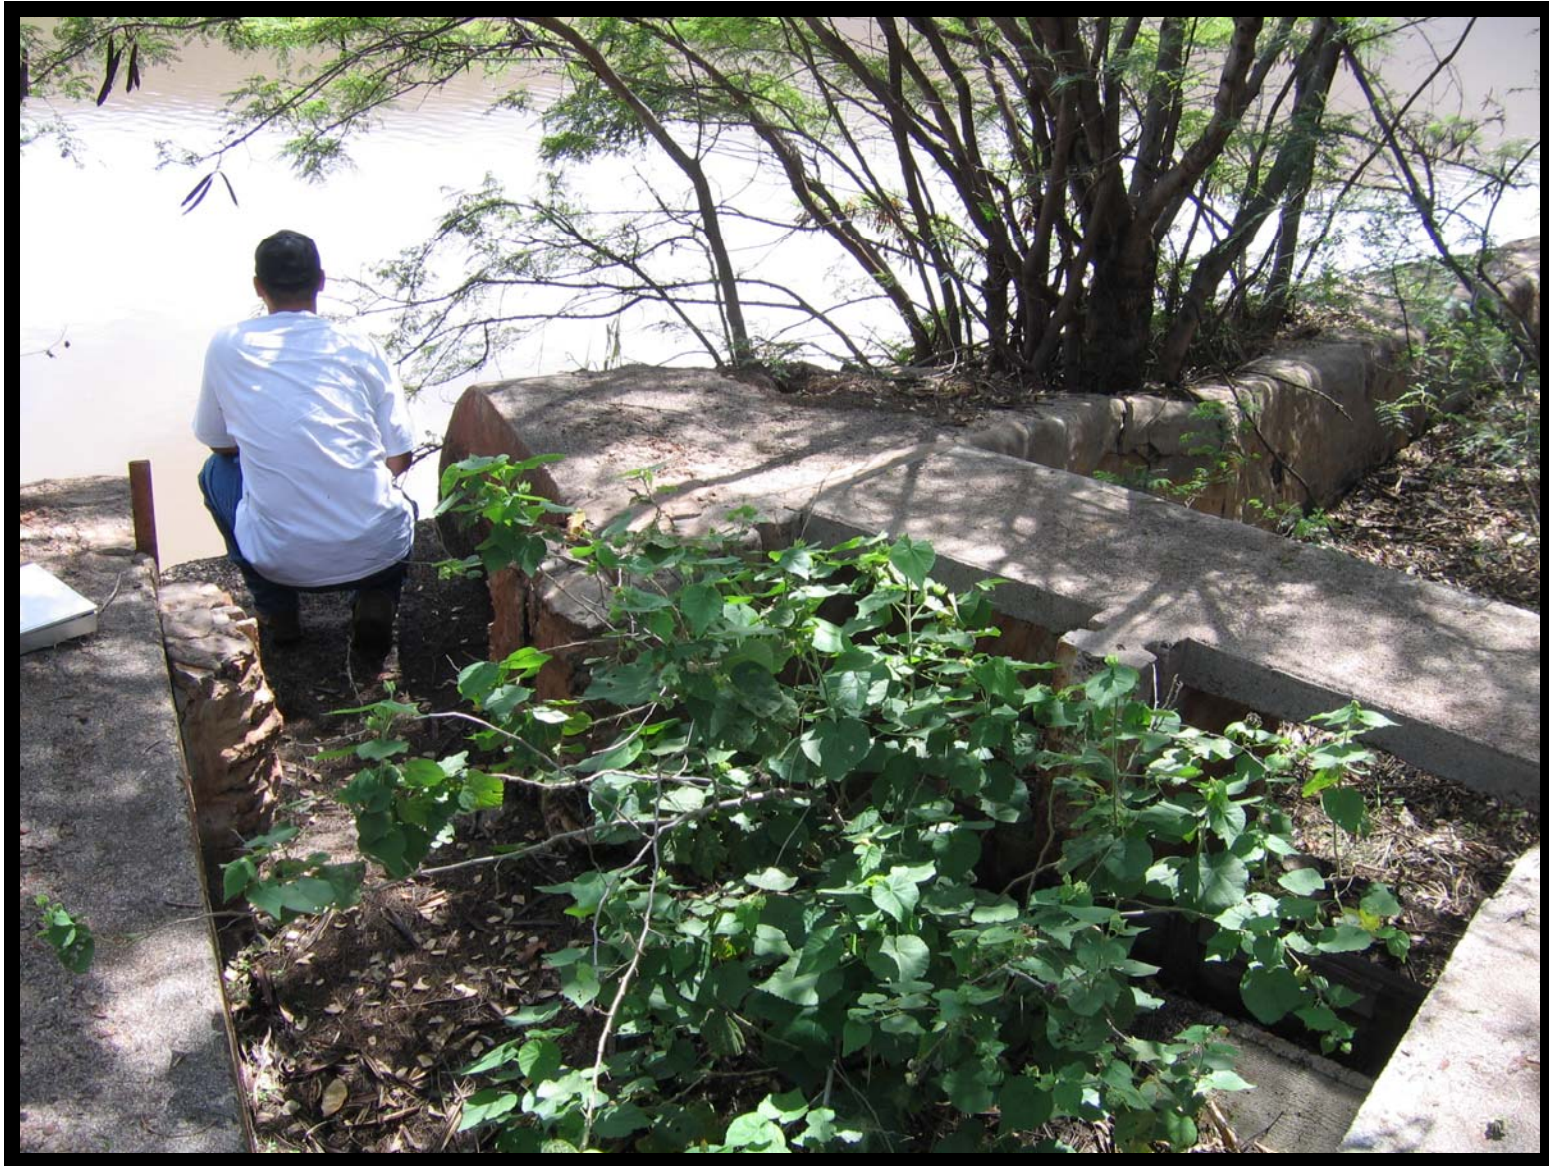
055 View of abandoned inlet diversion right of downstream spillway

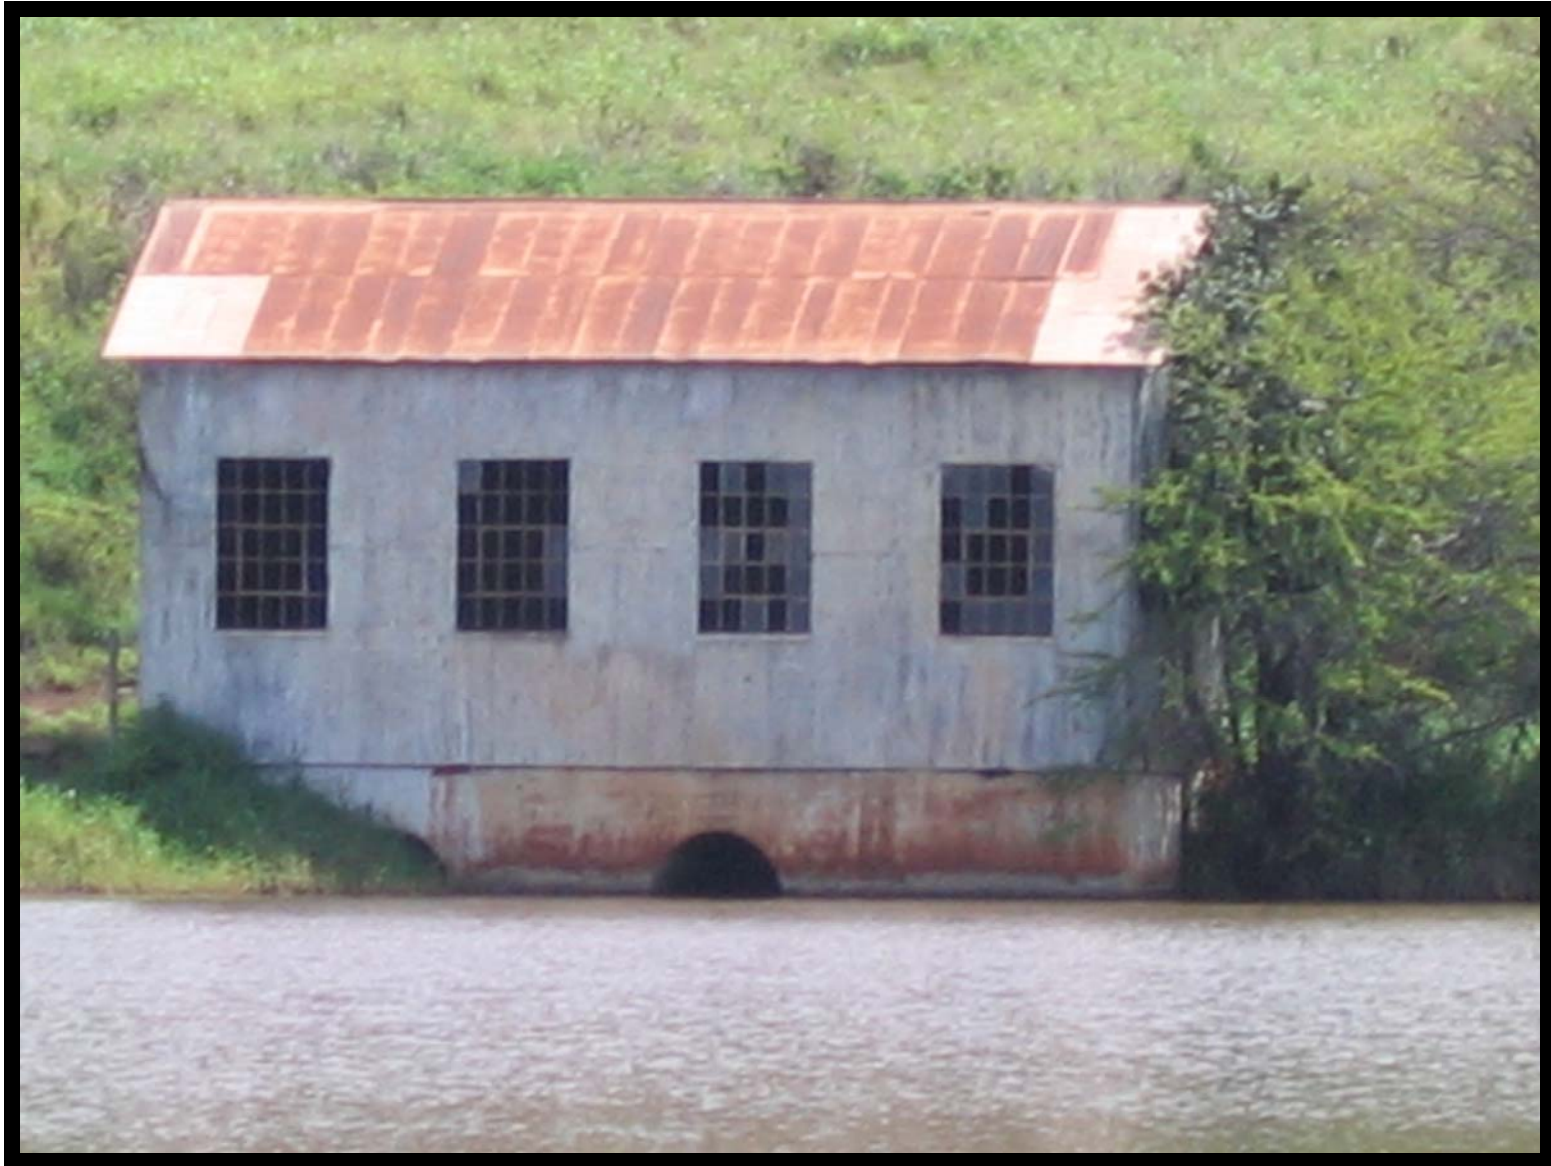
055 View of inlet pipe from abandoned hydroelectric pumphouse

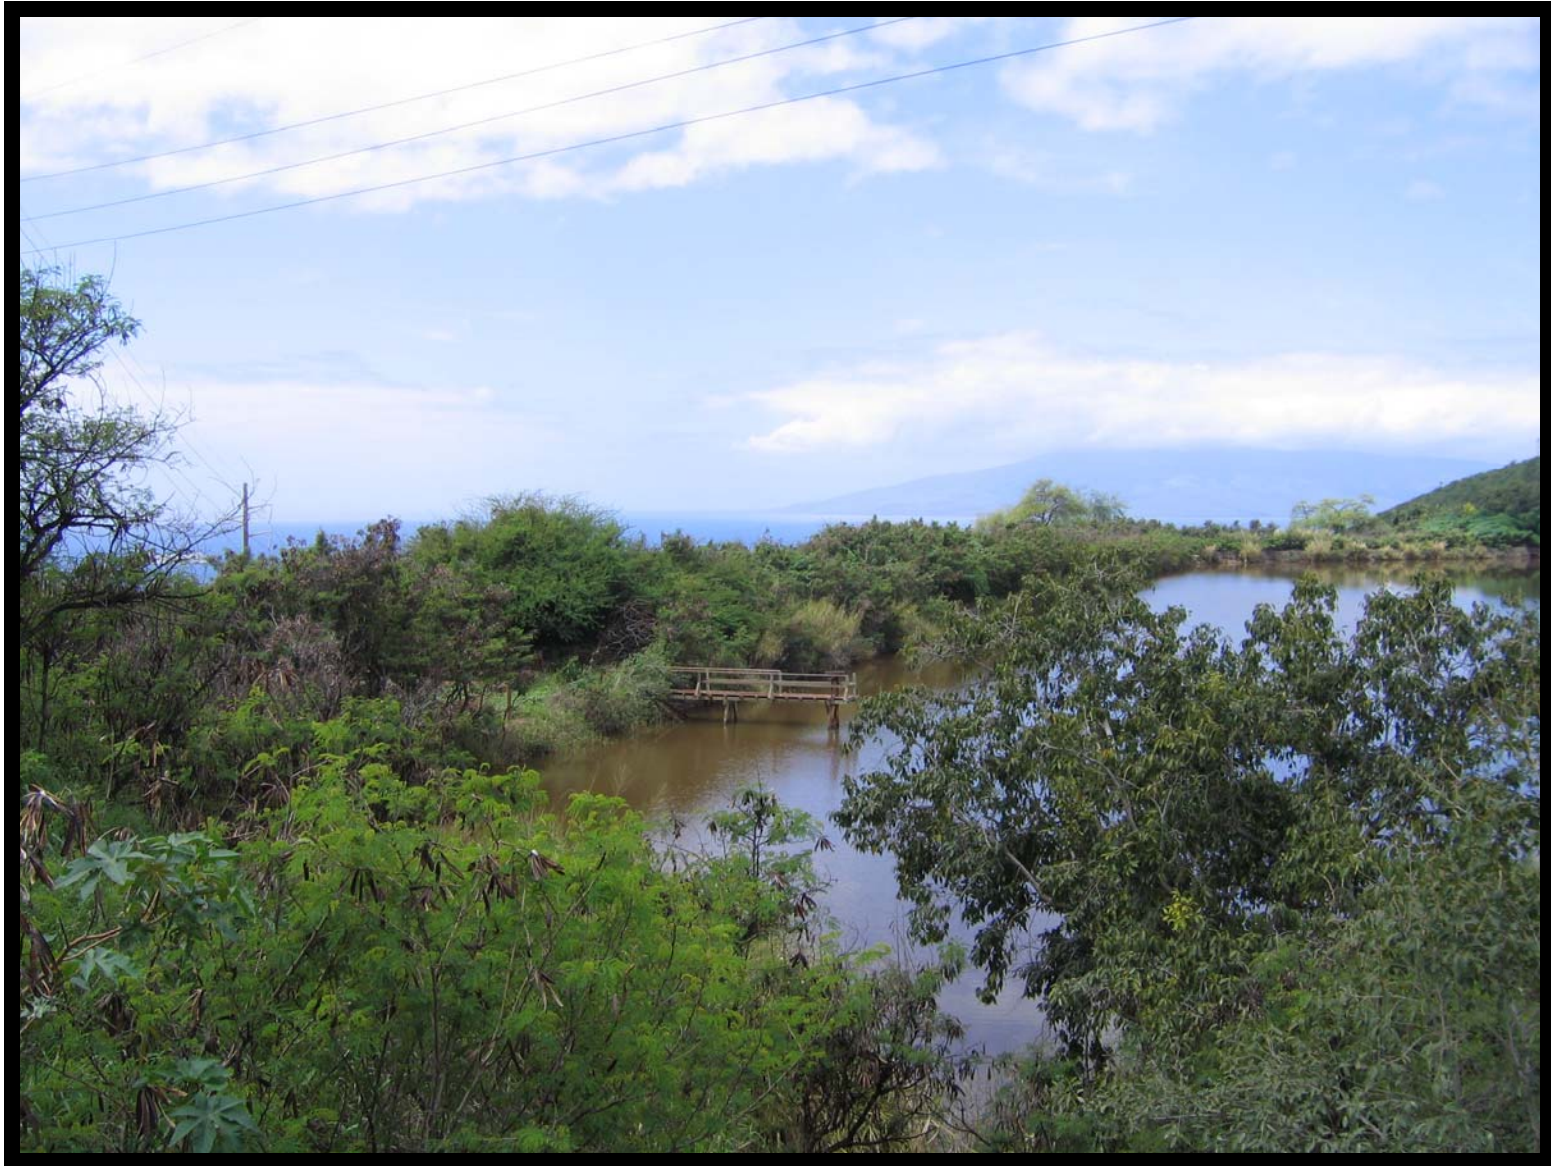
055 View of left side outlet works valve control reported to work

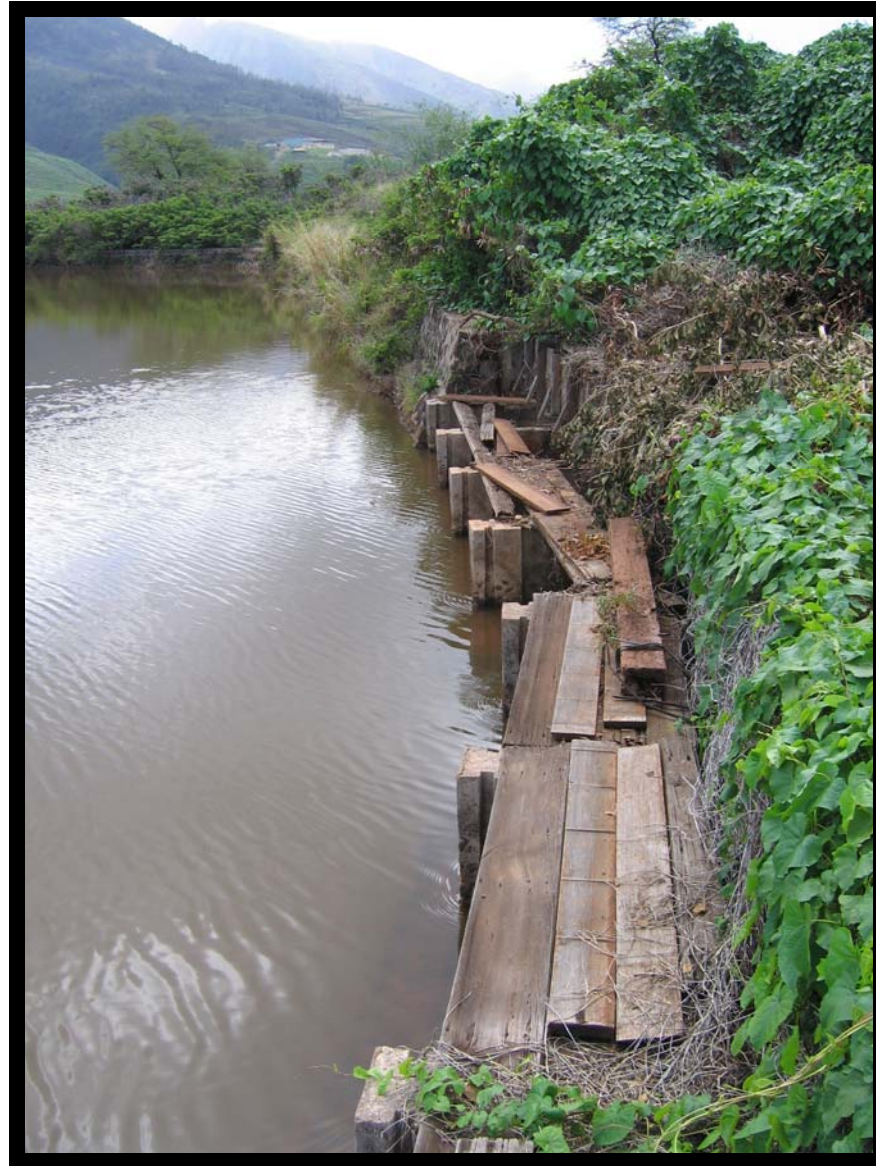
055 View of spillway inlet, some of
pong boards in place

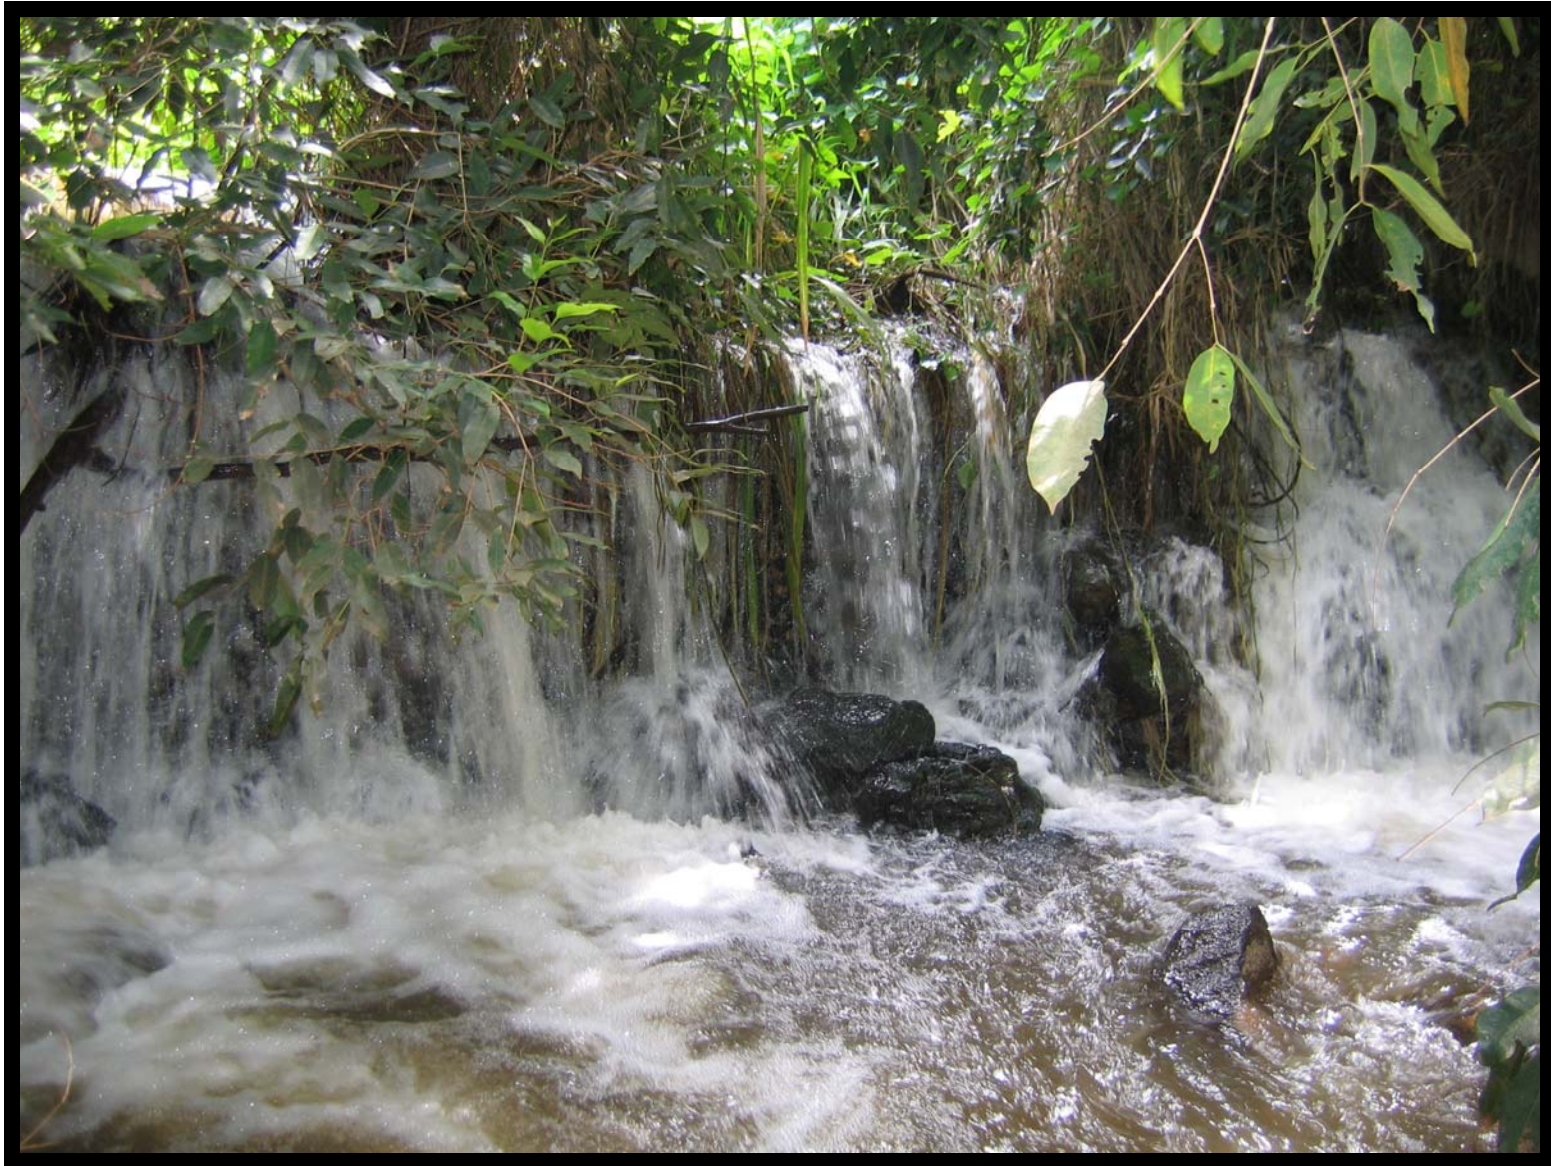
This spillway consisted of a channel made of concrete. The spillway was overgrown with vines, bushes and trees. There was no erosion observed near the spillway.

- a. The reservoir appeared to be in fair to poor condition, and requires corrective action to remove the vegetation.
- b. The spillway is blocked by vegetation growth.

055 View of massive overgrowth of vines and trees at spillway outlet.

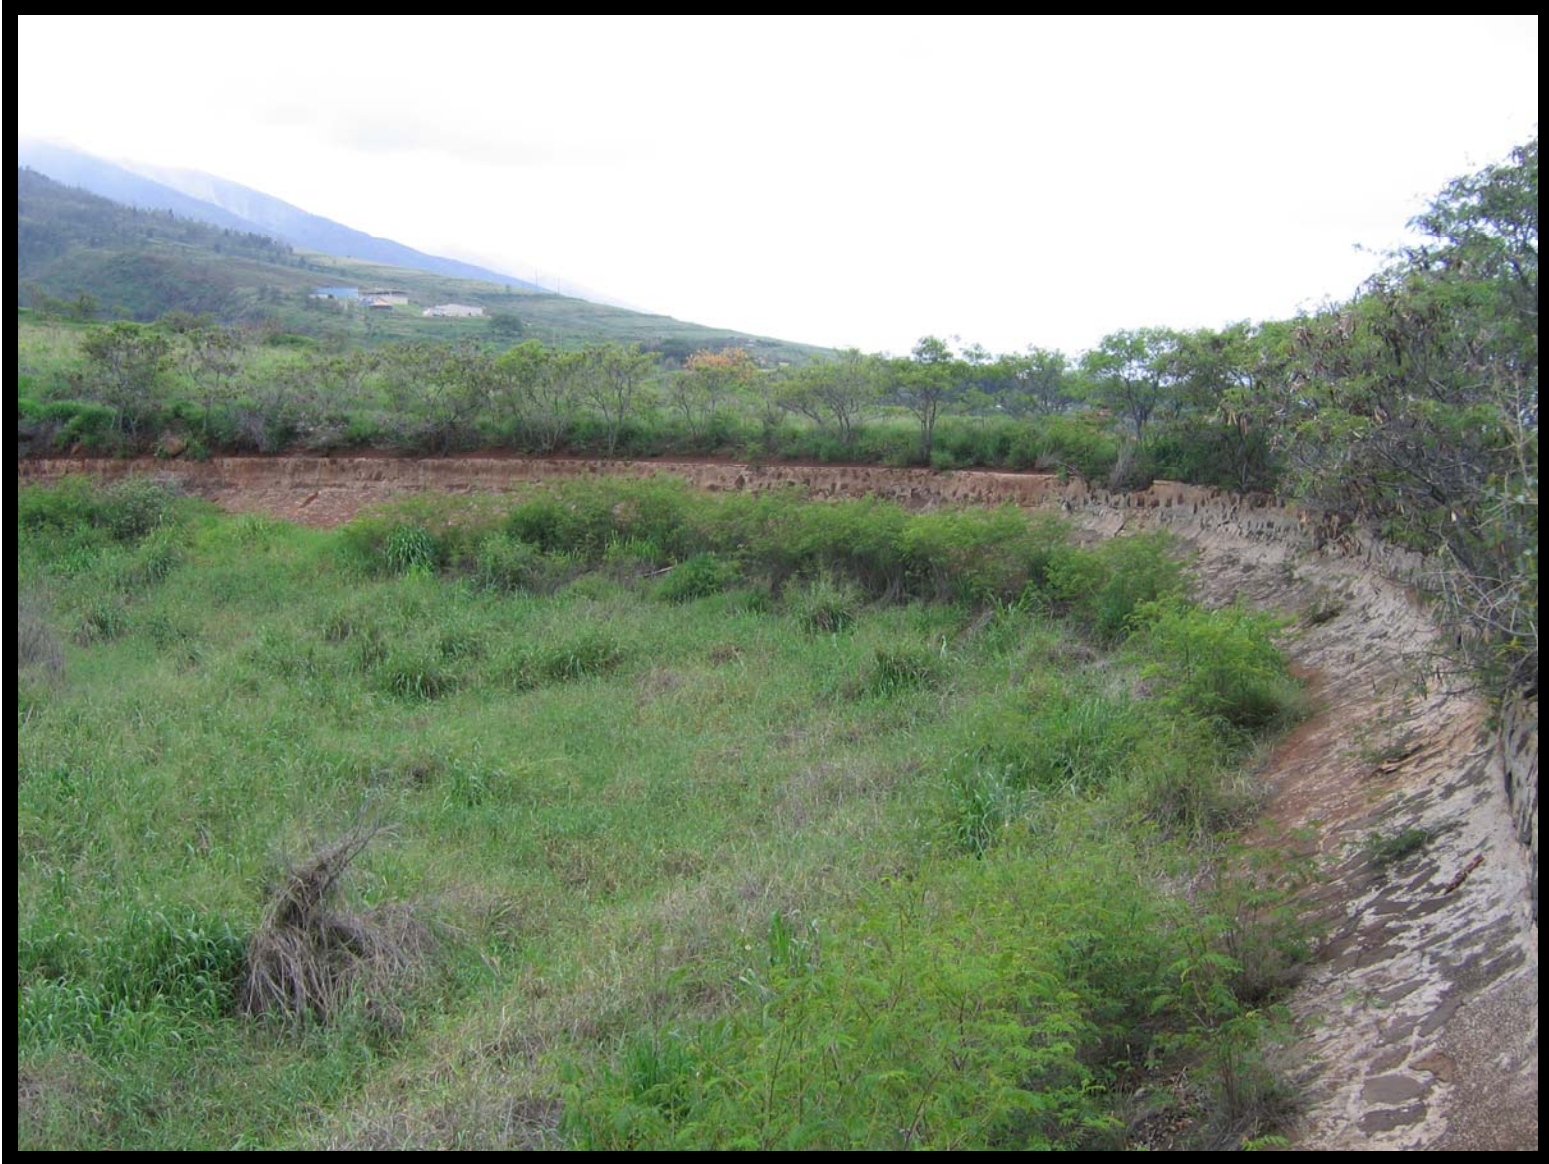
055 View of abandoned upper reservoir with grouted stone slopes.

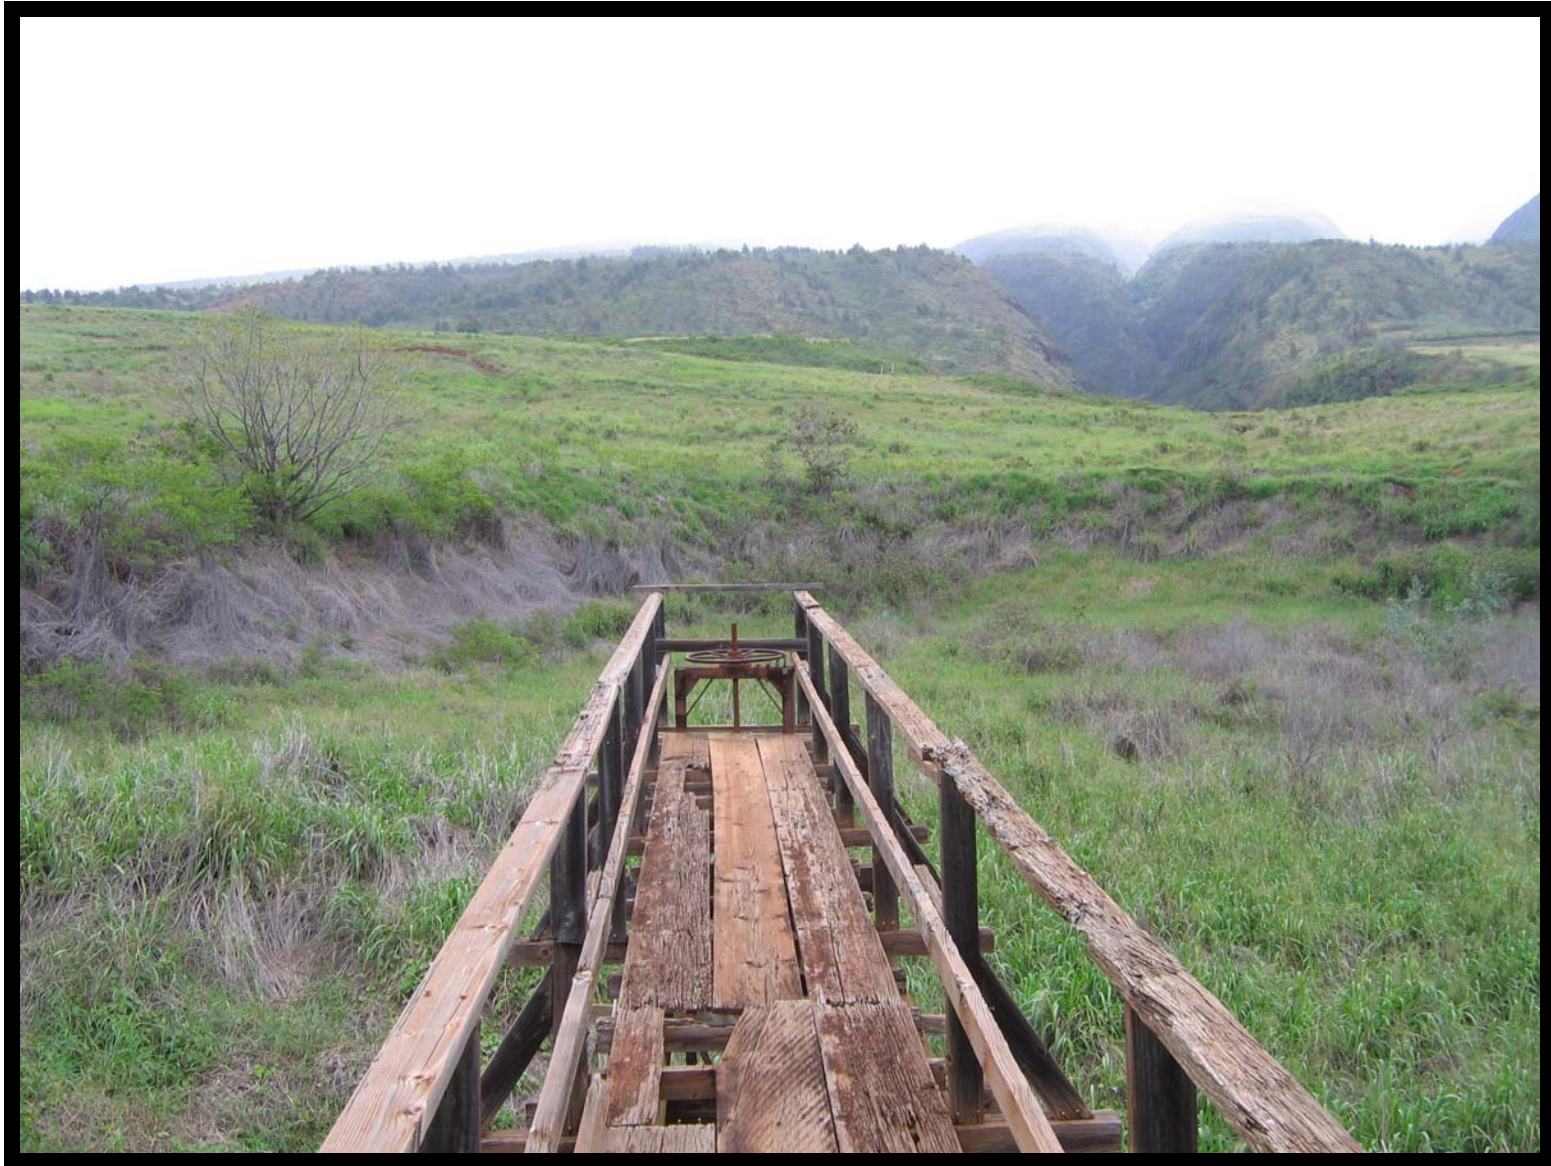
055 View of abandoned outlet works valve looking upstream
